# Manhole Inspection Summary

Manhole # S09EE1008MH

Insp Date: **9/24/07 10:50 AM**

**Location** Address: **BELLE AVE**

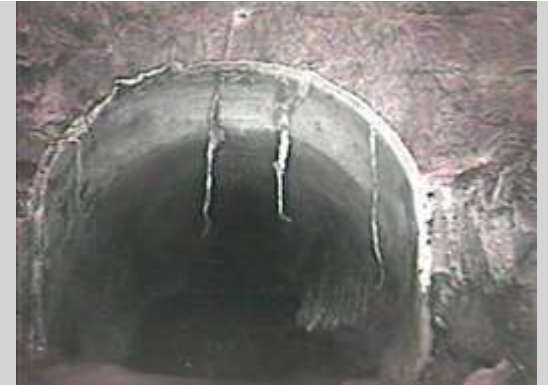
12 O'Clock Outflow

15 in. Circular Gravity Sewer  
Pipe Out @ 12 O'Clock

Pipe Material: **Clay** ☐ Pipe Lined

Invert Depth: **9.83** (ft.) Flow Characteristics: **Fast**

Deposits: ☒ None ☐ Mud ☐ Sludge ☐ Debris ☐ Grease

Infiltration: **None** Pipe Seal Cond: **Sound**

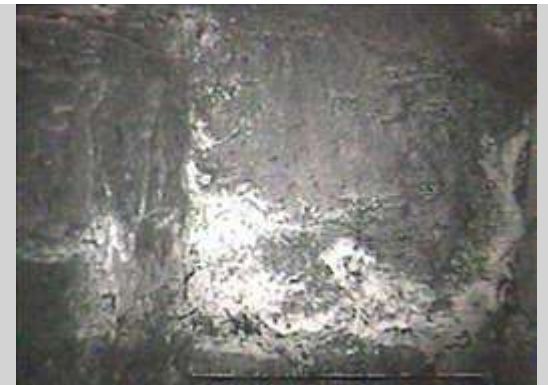
3 O'Clock Inflow

8 in. Circular Gravity Sewer  
Pipe In @ 3 O'Clock

Pipe Material: **Unknown** ☐ Pipe Lined

Invert Depth: **9.77** (ft.) Flow Characteristics: **None**

Infiltration: **None** Pipe Seal Cond: **Sound**

Connects To: **Stub connection / abandoned**

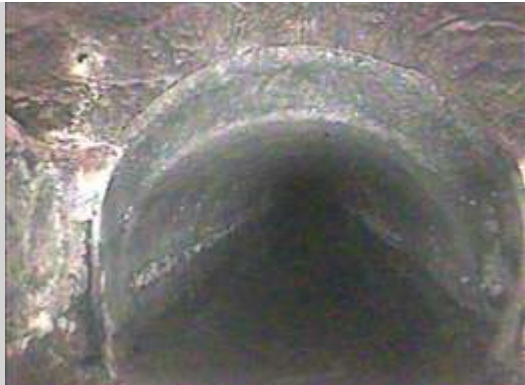
6 O'Clock Inflow

15 in. Circular Gravity Sewer

Pipe In @ 6 O'Clock

Pipe Material: **Clay** ☐ Pipe Lined

Invert Depth: **9.78** (ft.) Flow Characteristics: **Fast**

Infiltration: **None** Pipe Seal Cond: **Sound**

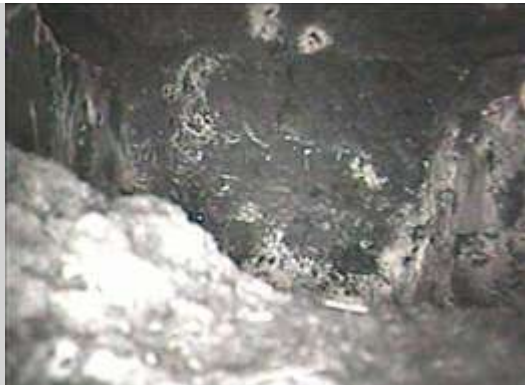
9 O'Clock Inflow

8 in. Circular Gravity Sewer

Pipe In @ 9 O'Clock

Pipe Material: **Unknown** ☐ Pipe Lined

Invert Depth: **9.73** (ft.) Flow Characteristics: **None**

Infiltration: **None** Pipe Seal Cond: **Sound**

Connects To: **Stub connection / abandoned**
